Debris/Ice/TPS Assessment And Photographic Analysis For Shuttle Mission STS-48

November 1991

Gregory N. Katnik
NASA/Kennedy Space Center

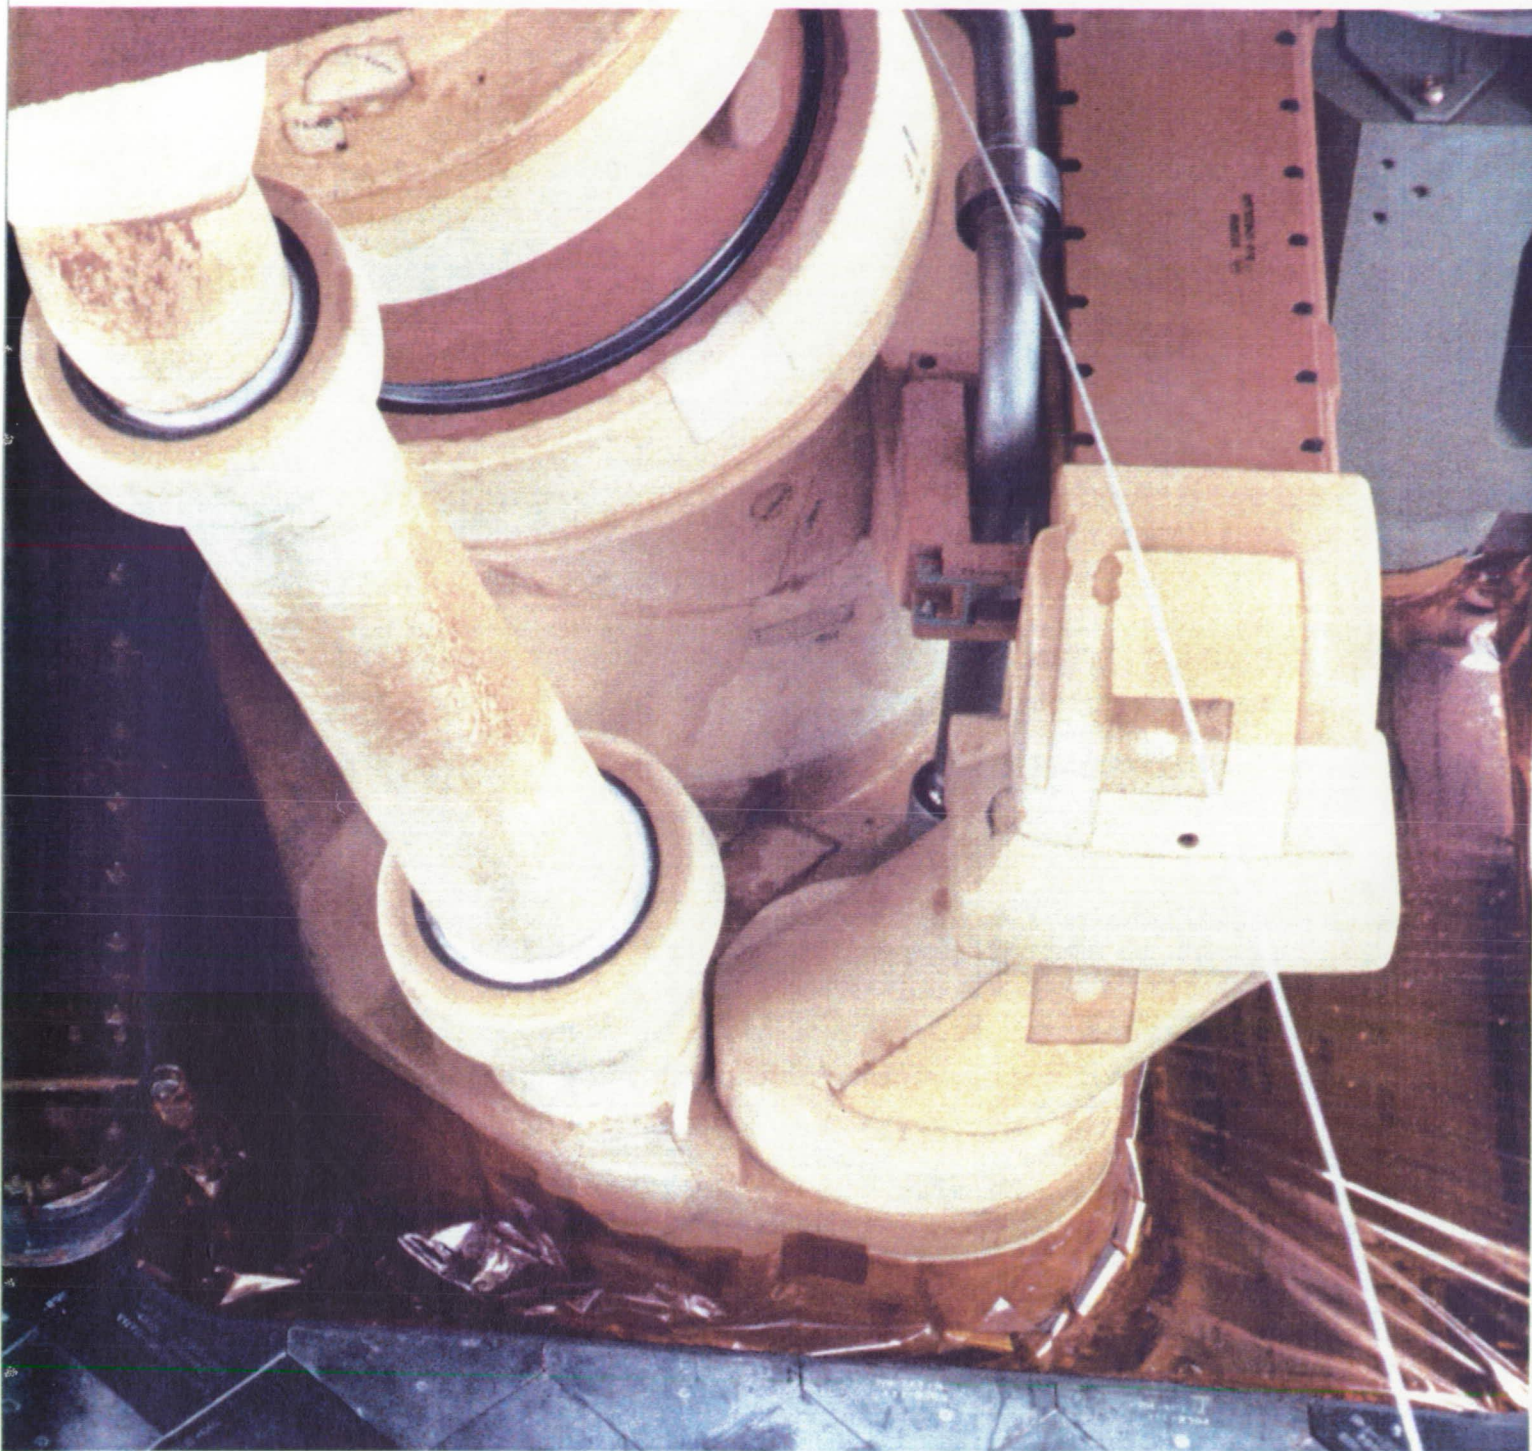
Less than usual ice/frost had accumulated on the inboard and aft sides of the LH2 ET/ORB umbilical. Ice/frost formations on the lower plate gap purge vent and in the LH2 recirculation line bellows were typical. The LH2 feedline bellows, cable tray vent hole, and 17-inch flapper valve actuator tool access port closeout exhibited no ice or frost accumulations.

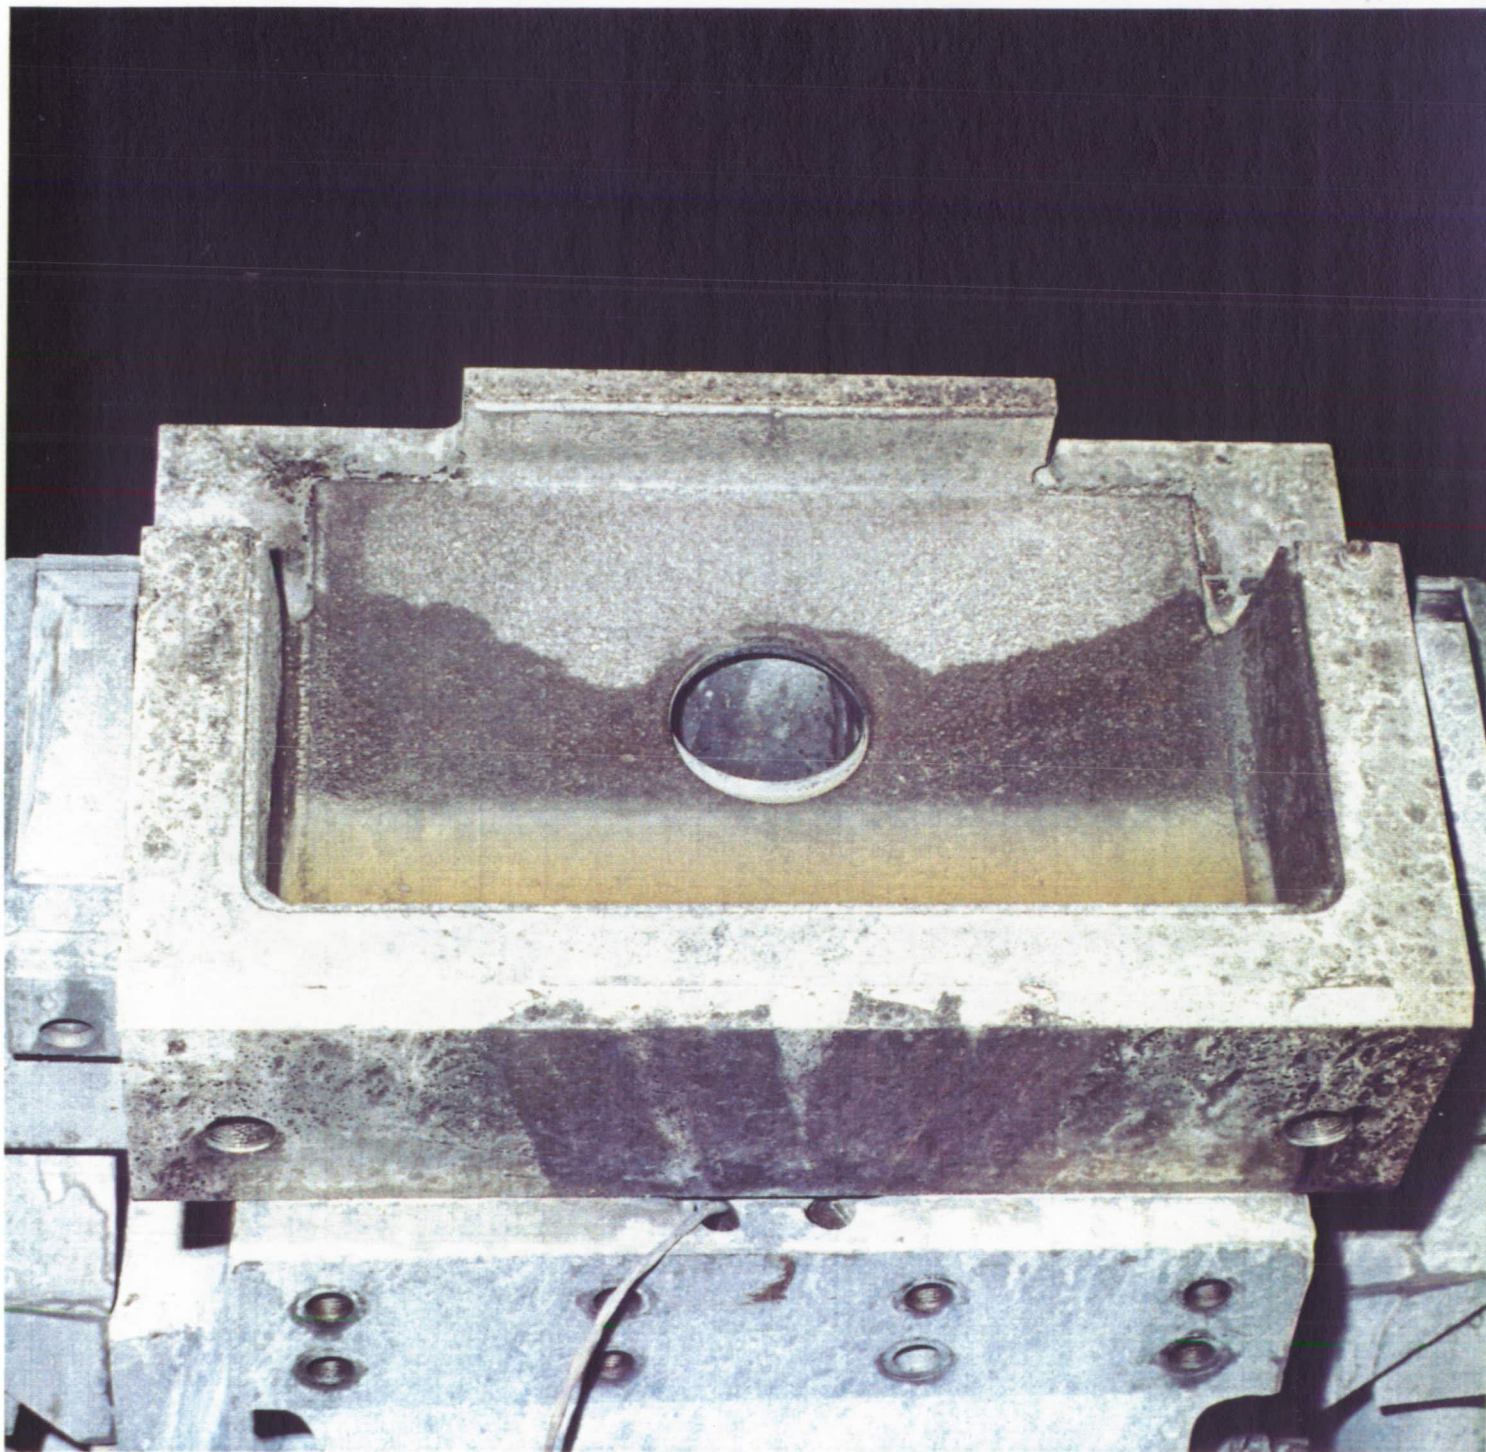
Plume erosion of the south SRB holddown posts was typical. All EPON shim sidewall material and shim bottom plate material was intact and bonded to the shoes. There was no visual indication of a stud hang-up on any of the south holddown posts.

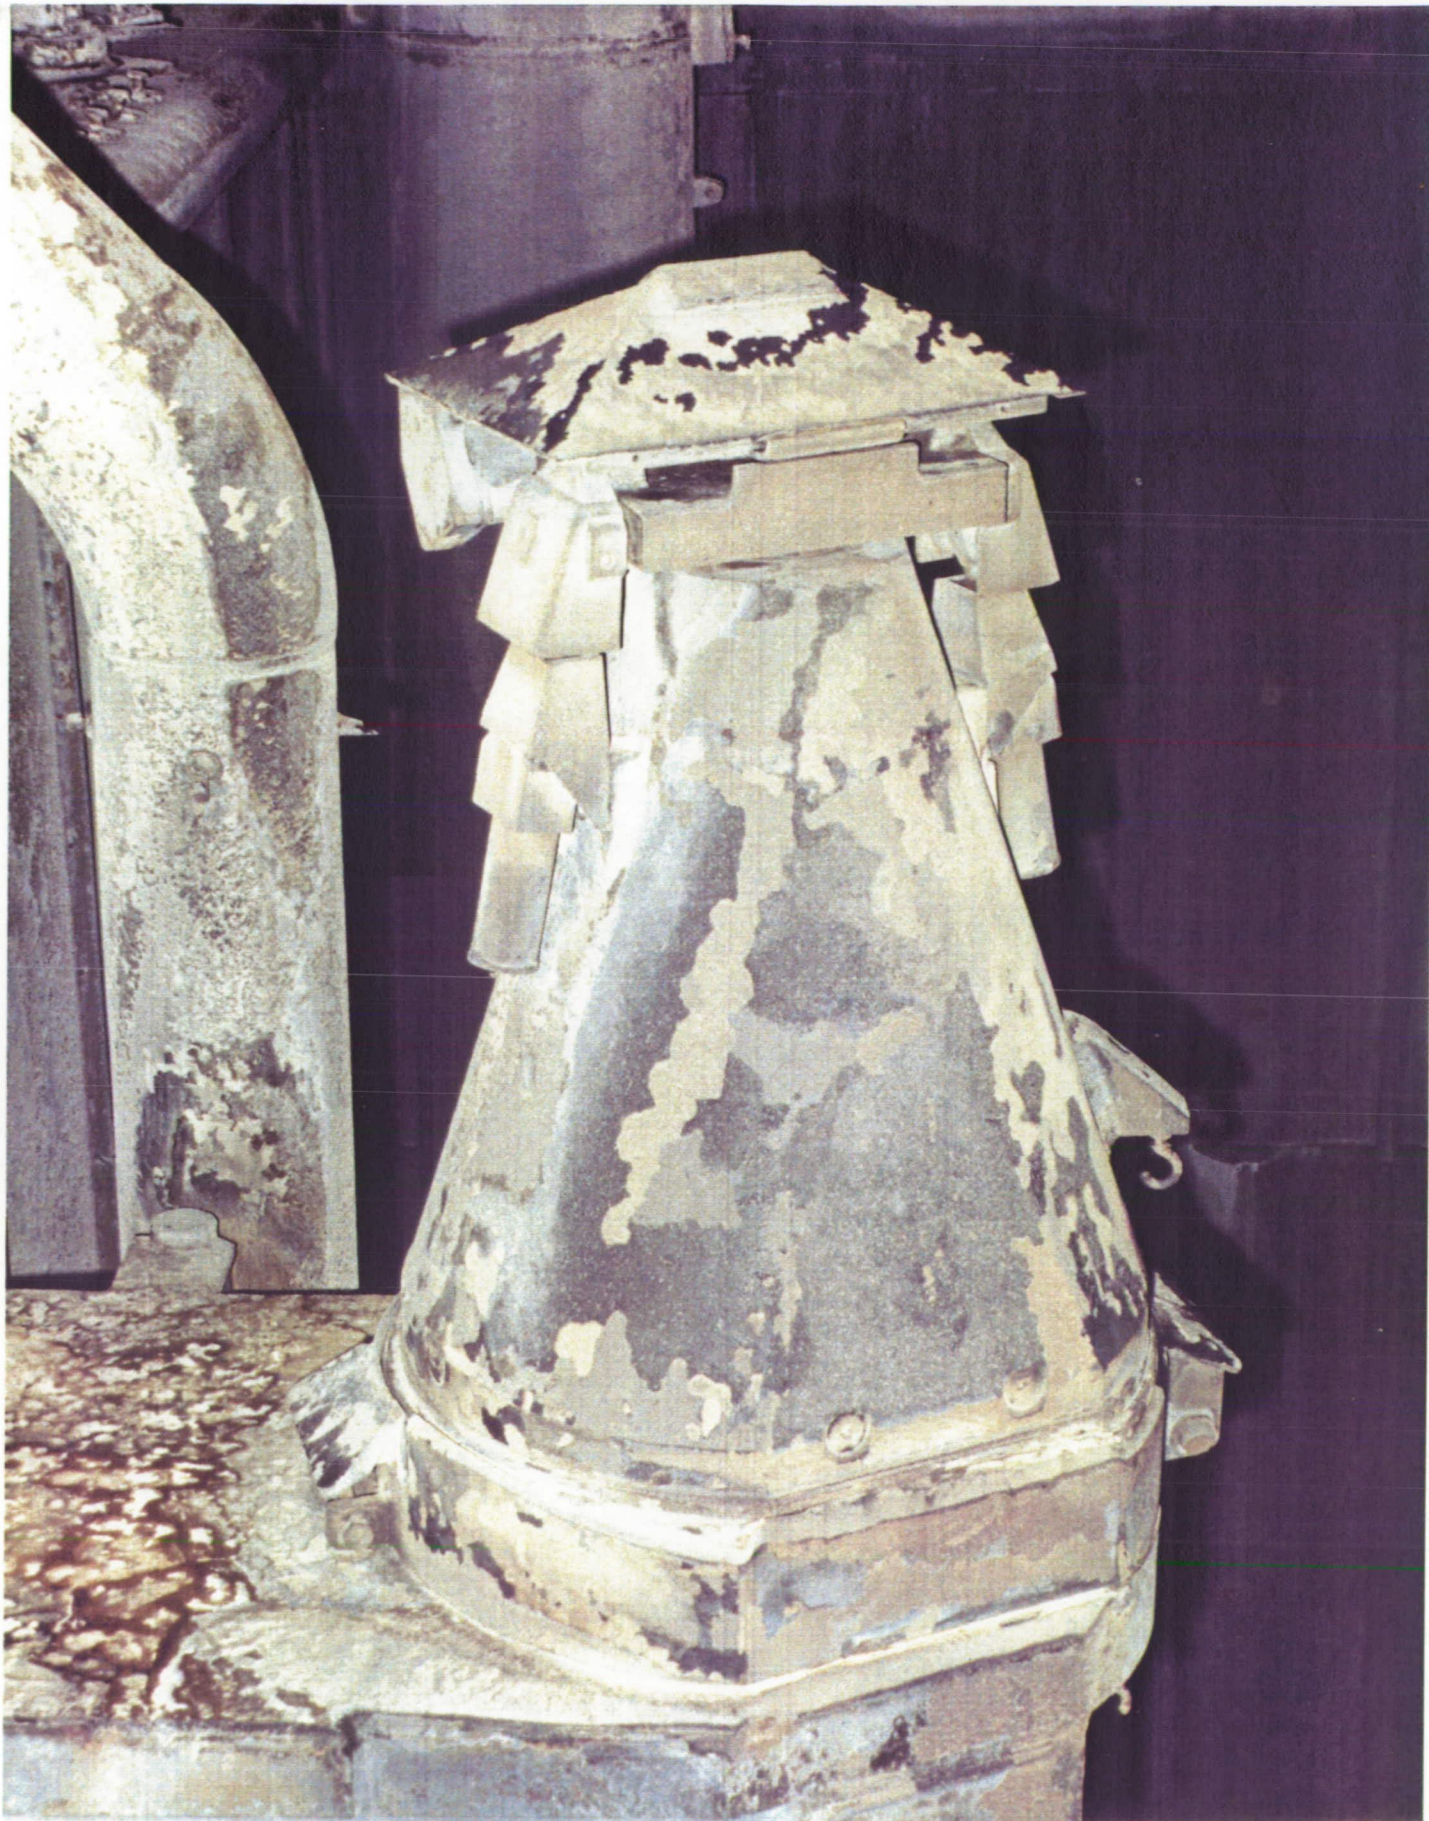
North HDP blast covers were in the closed position and exhibited typical SRB plume erosion effects

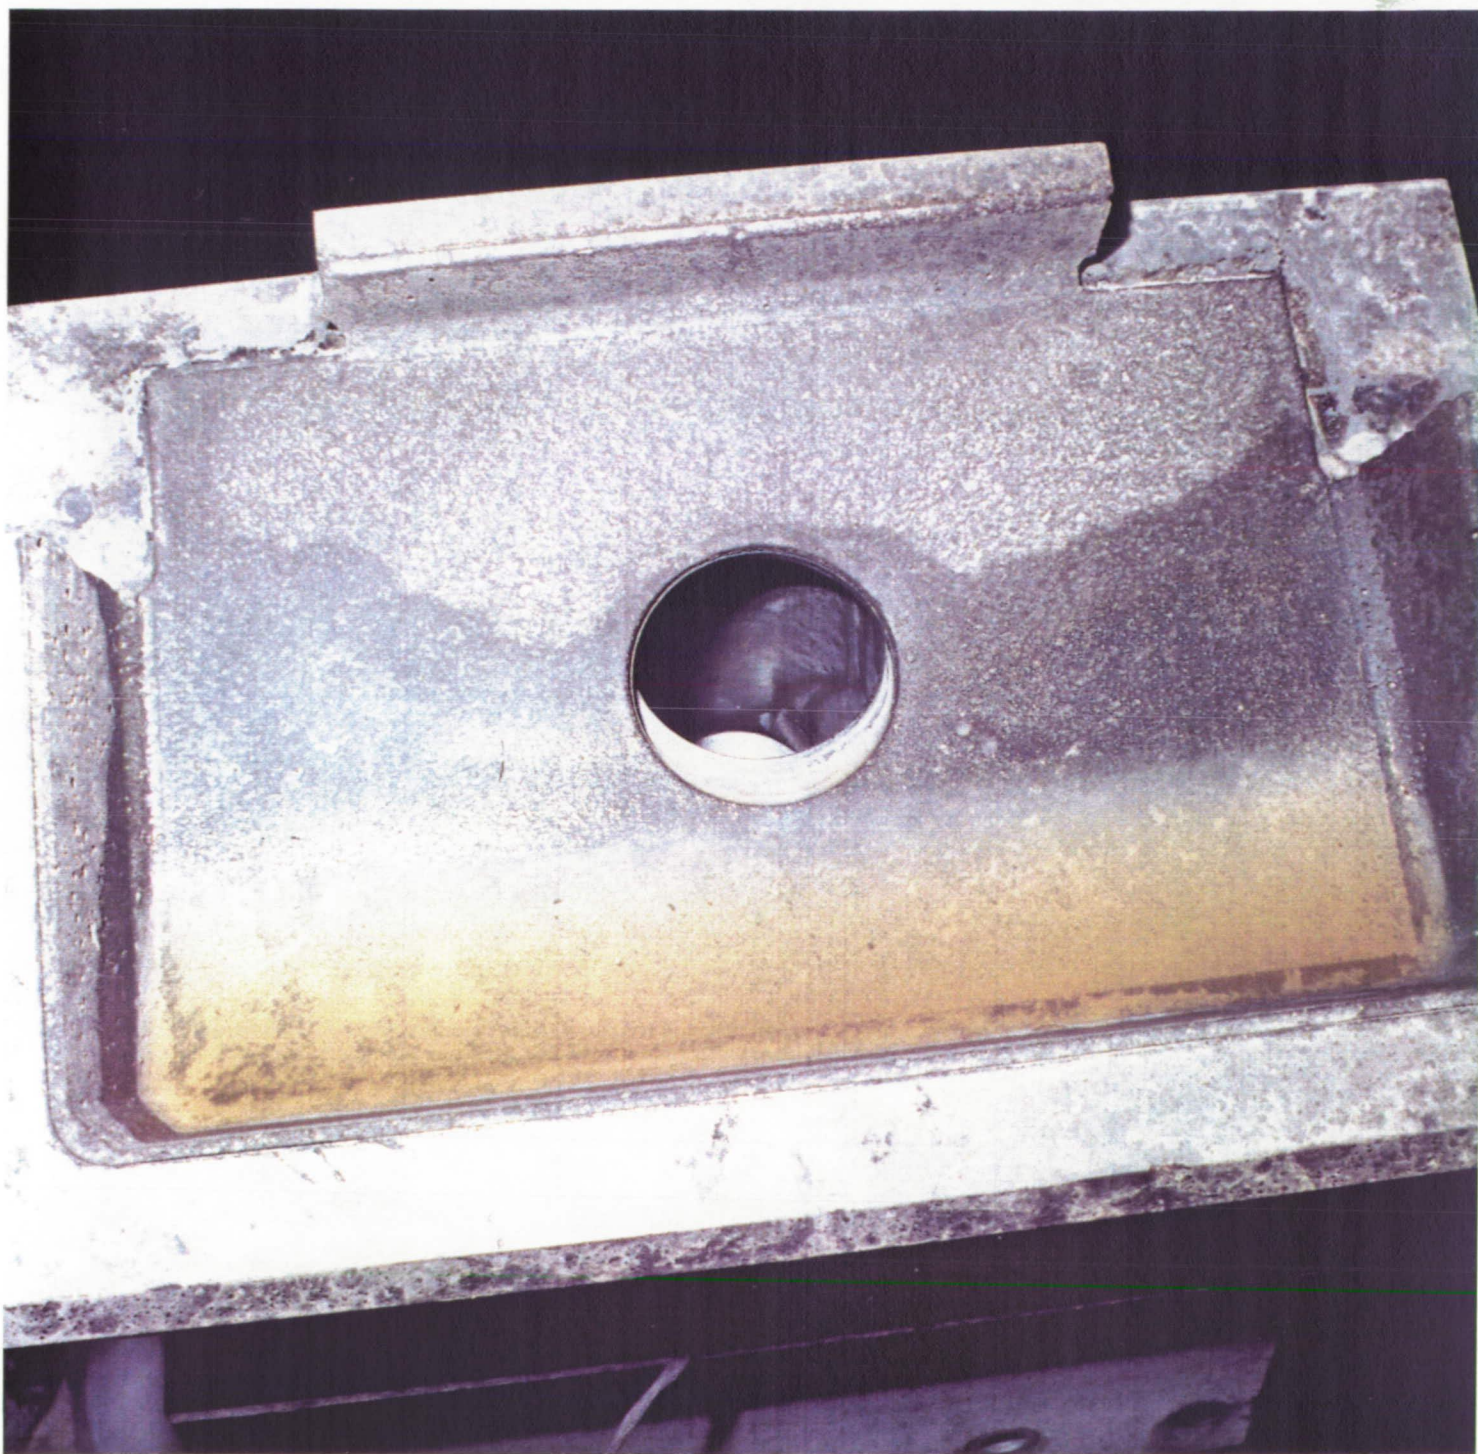
Frangible nut/ordnance fragments lay on the stud in HDP #5. These fragments had not been retained by the Debris Containment System (DCS) and fell from the aft skirt stud hole shortly after liftoff.

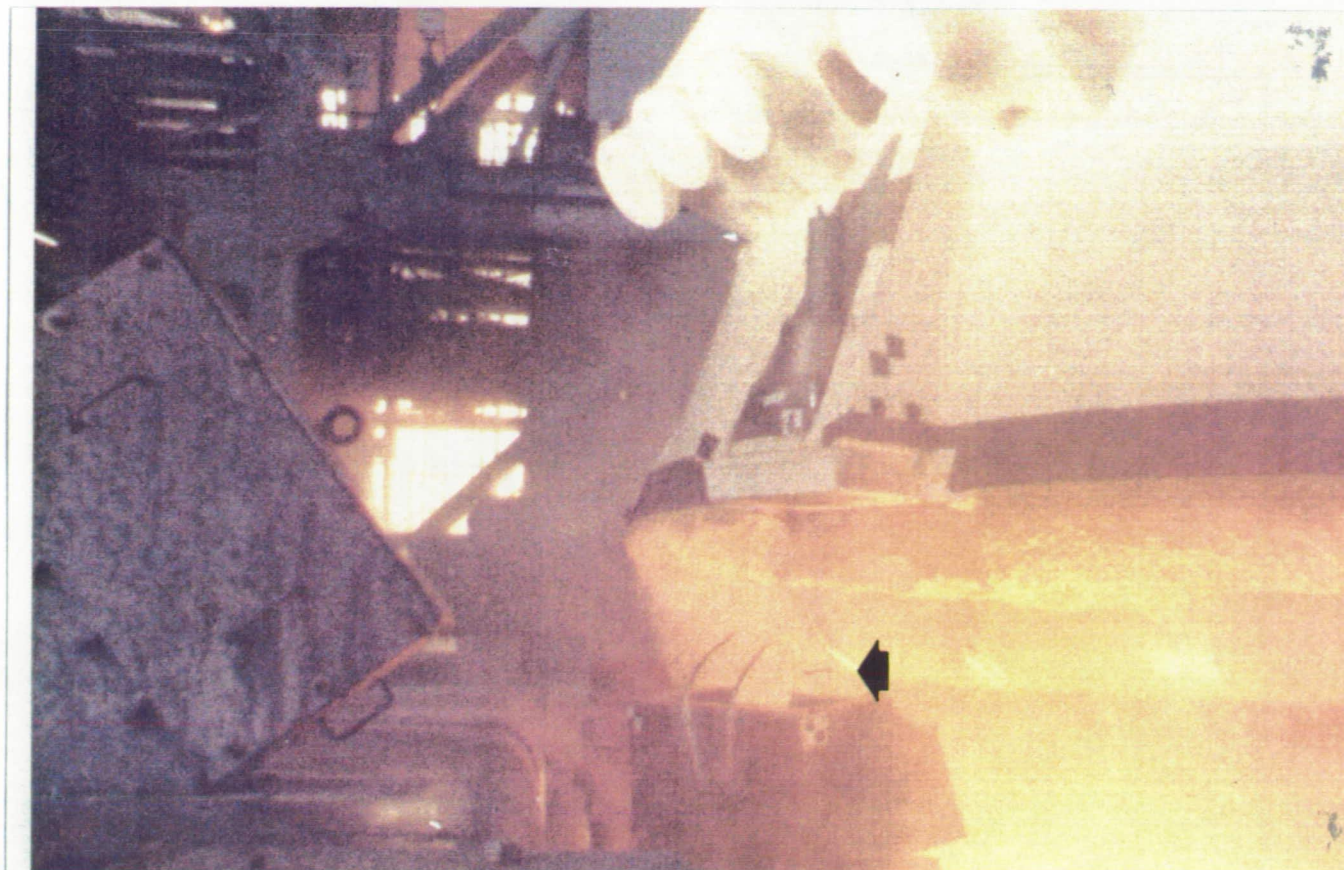
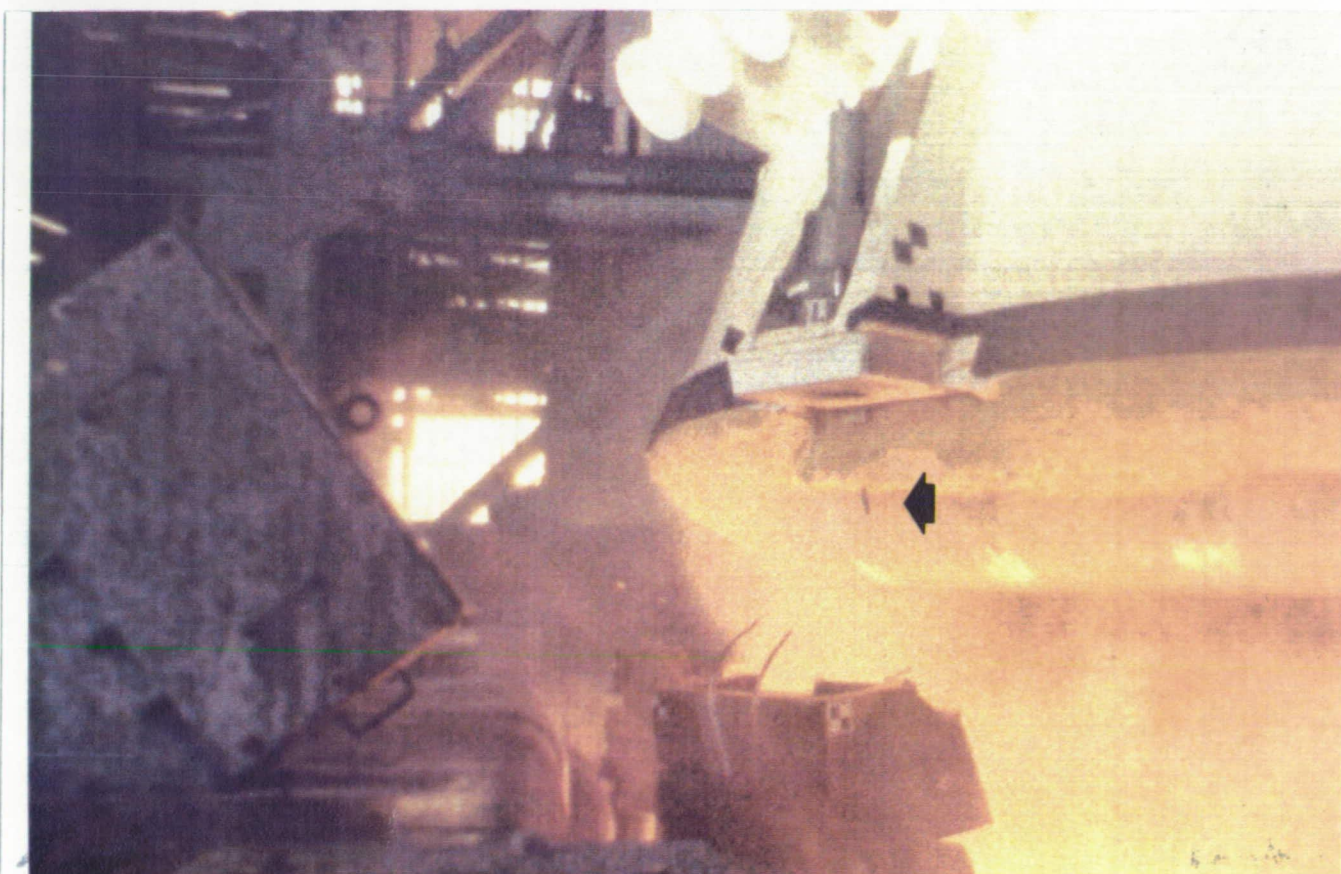
Shortly after liftoff, five ordnance fragments including two NSI booster pieces or frangible nut webs (3 inches in length), fell from the HDP #5 DCS/stud hole.

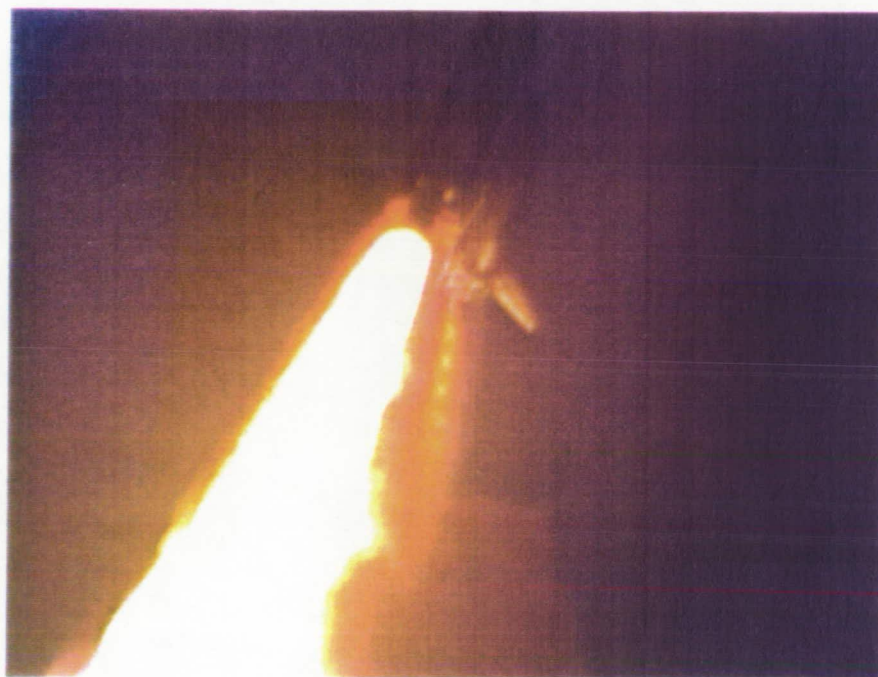
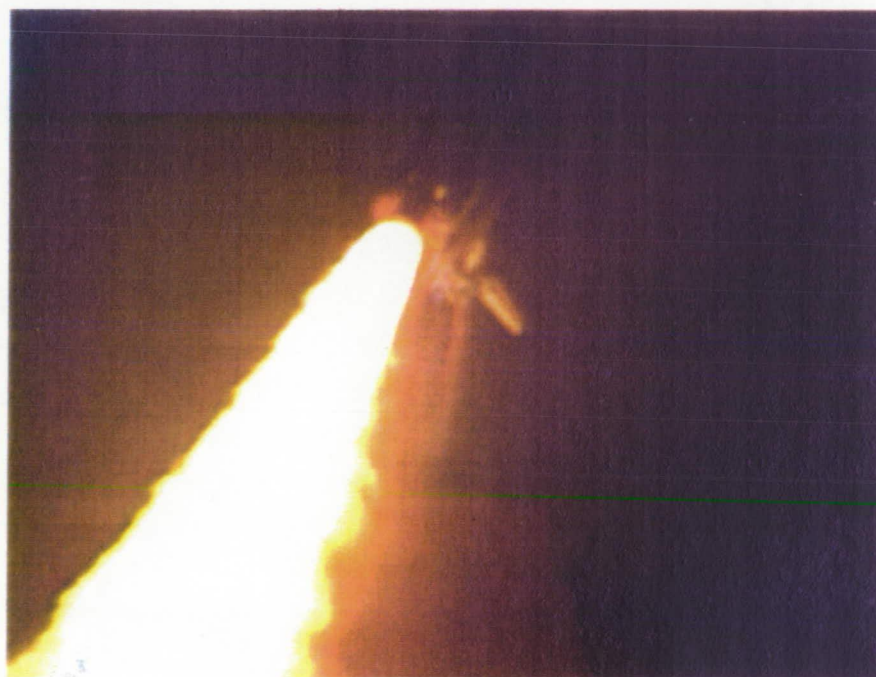
Two large orange flashes occurred in the SSME plume during ascent at T+29 seconds MET from SSME #2 and at T+31 seconds MET from SSME #1.

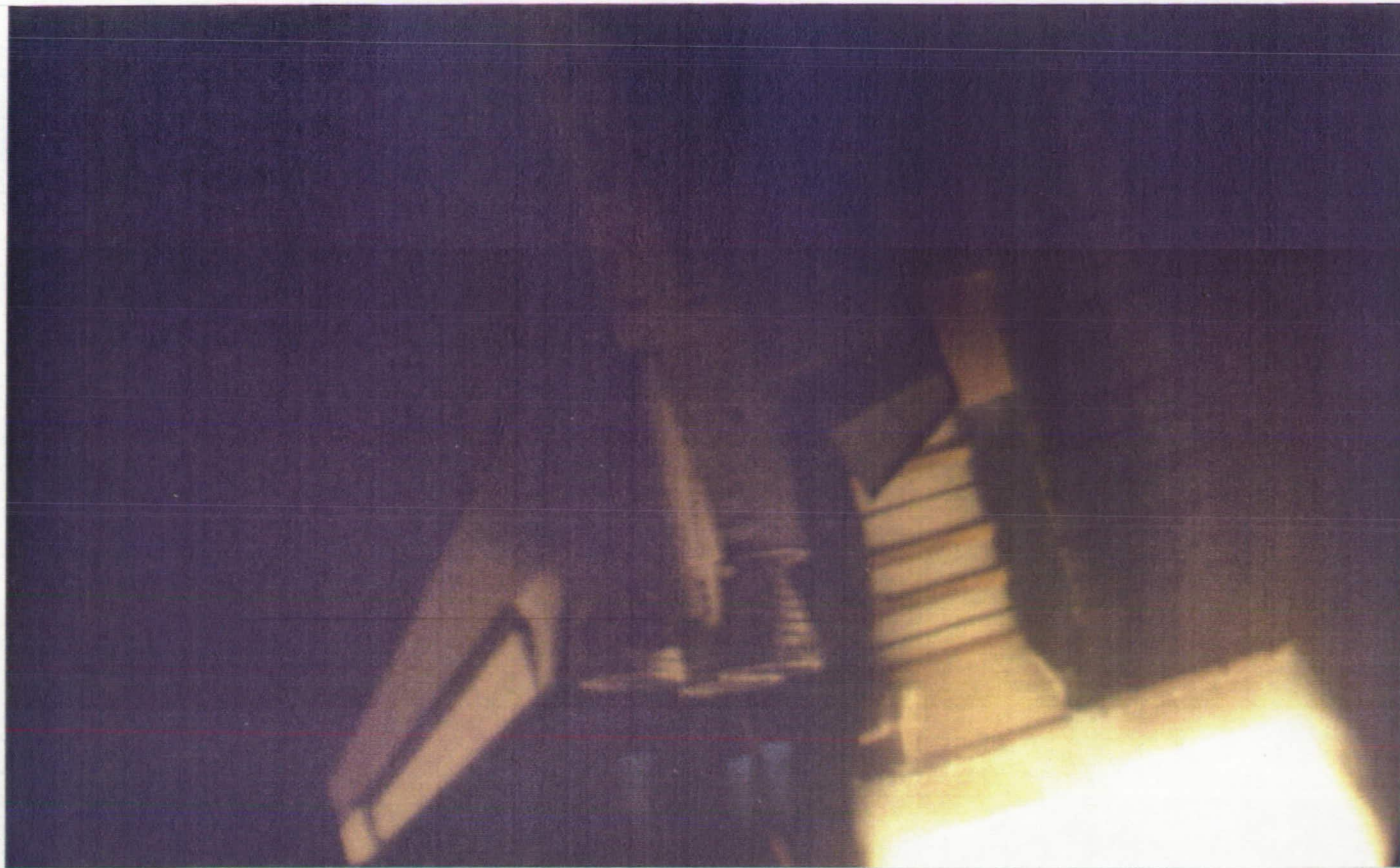
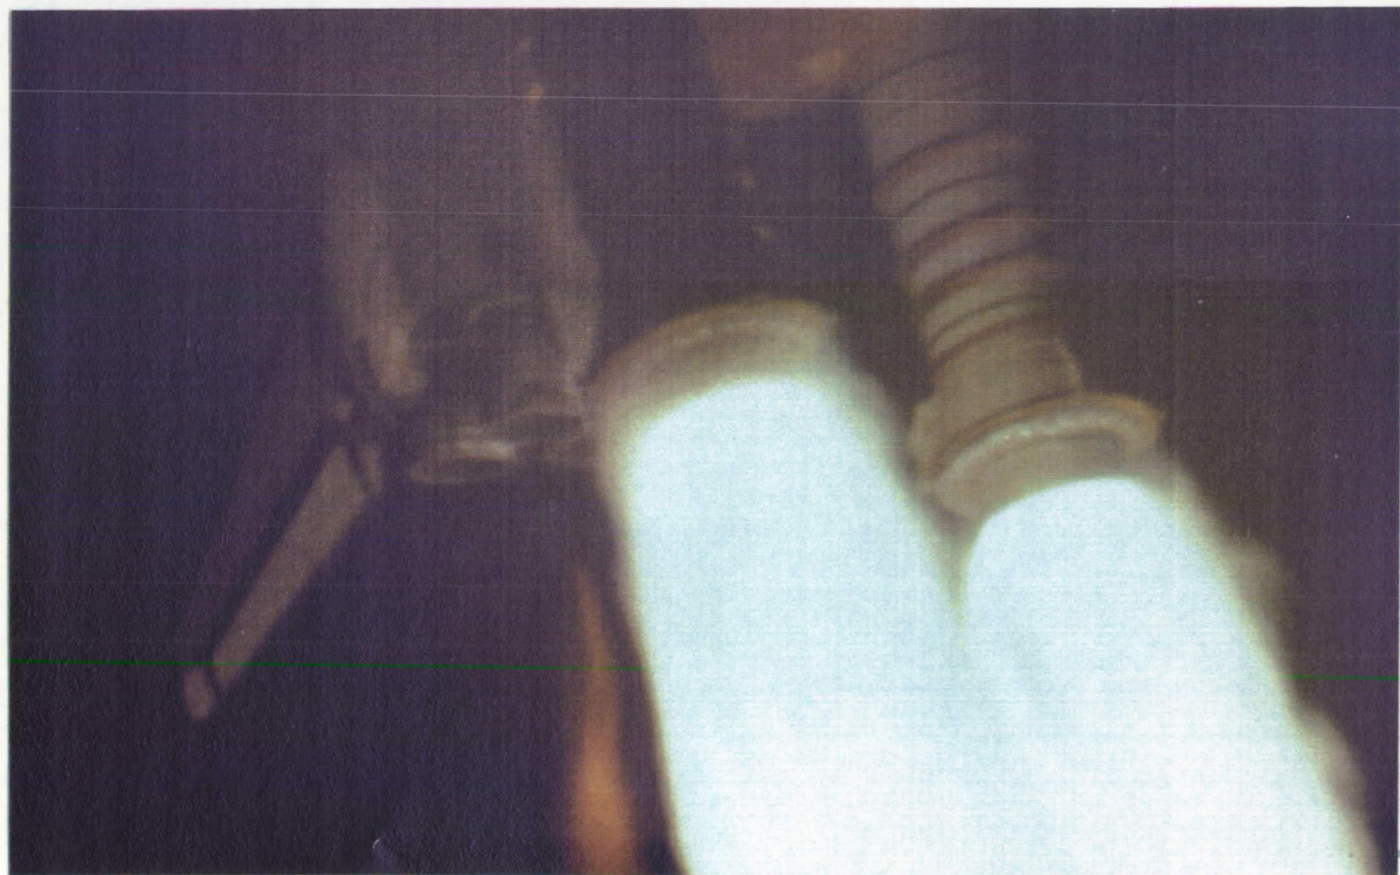
Pieces of paper covers from the LH FWD RCS fell past the aft end of the Orbiter (top photo). Orange streaks in the SSME plume are typically caused by debris particles, such as the RCS paper covers, entering the plume (bottom photo).

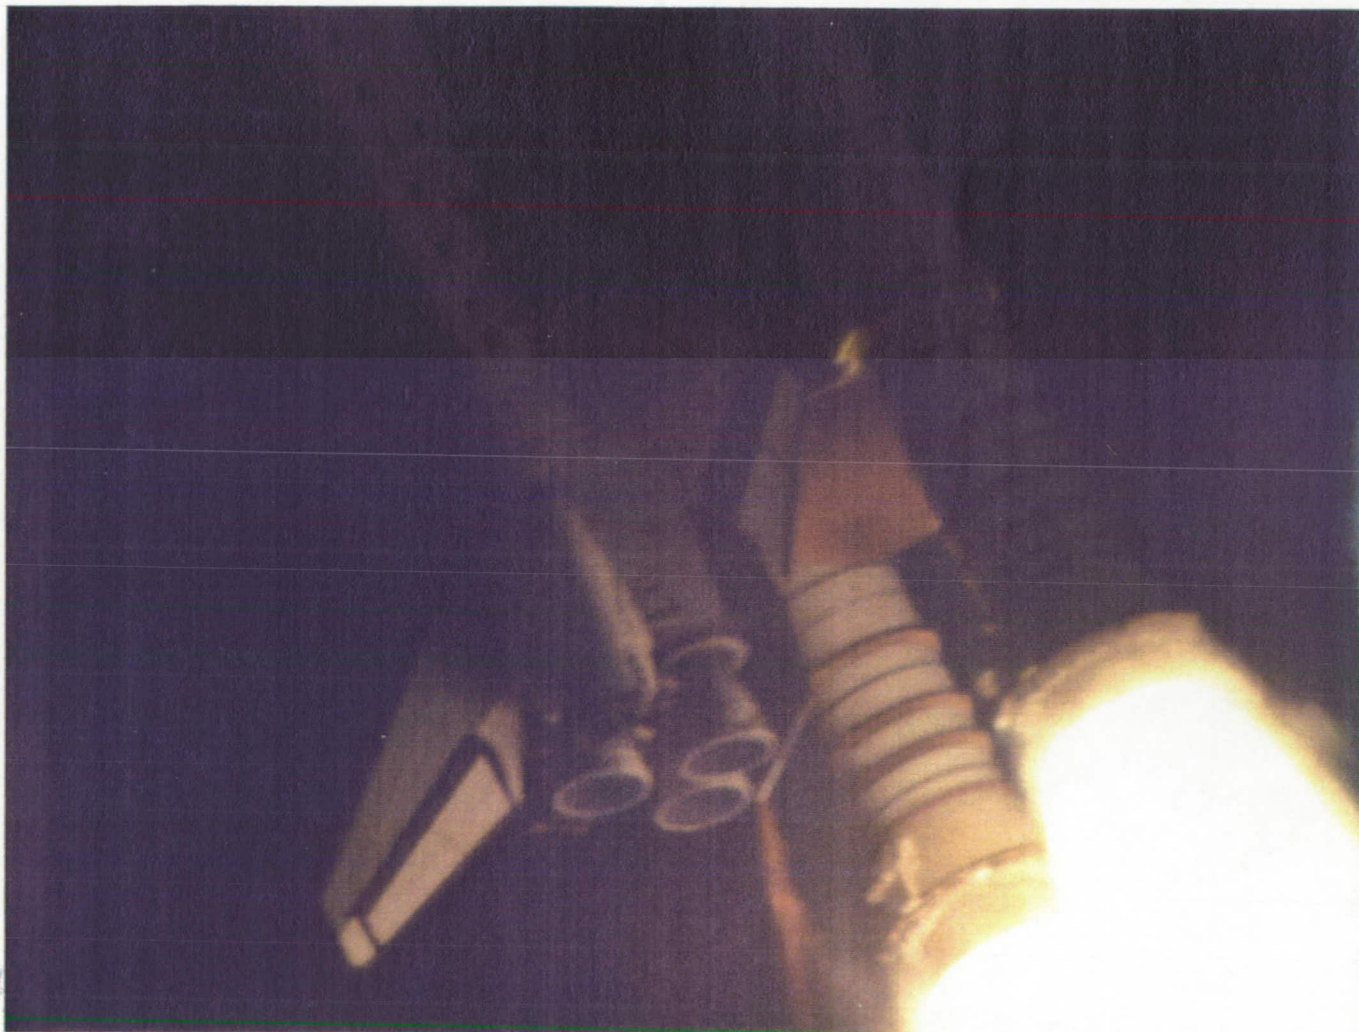
Orange flashes within the SSME plume itself may be
indicative of fuel impurities.

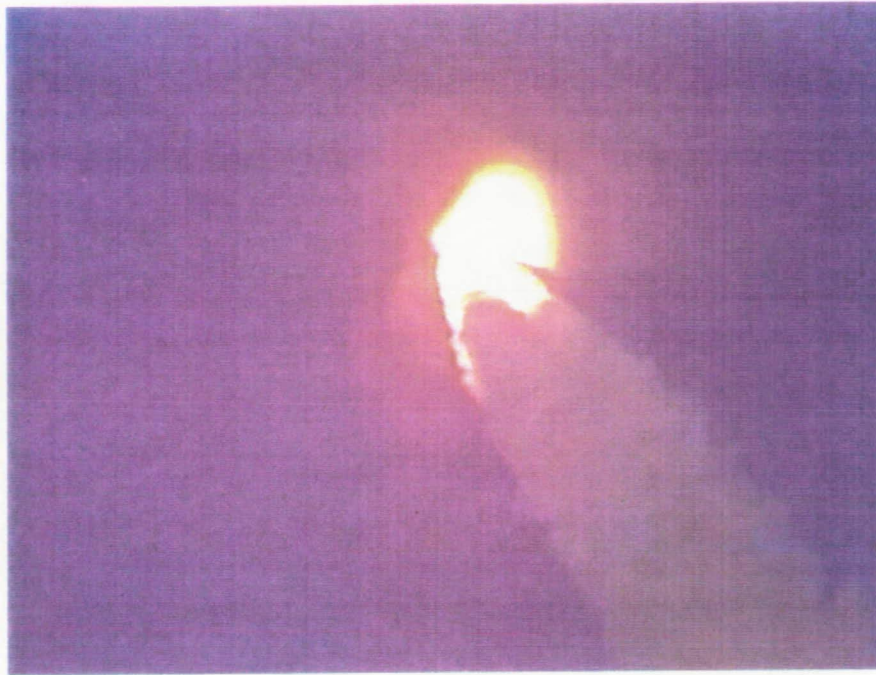
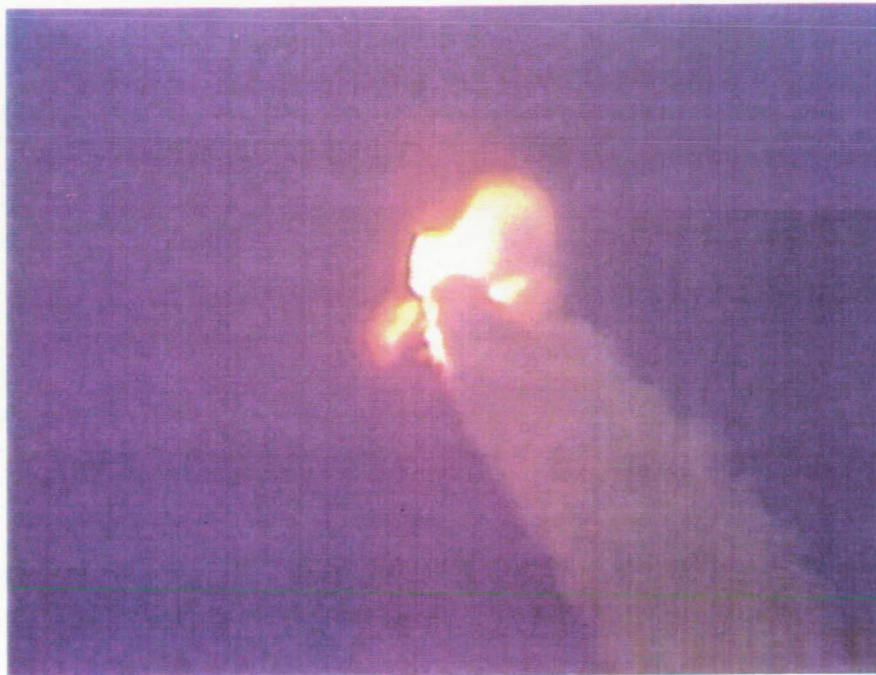
At T+58 seconds MET, the vehicle passed through a layer of cirrus clouds containing moisture or ice particles and a bright cloud of condensation/reflection surrounded the vehicle. The event was caused by atmospheric effects and was not a vehicle problem.

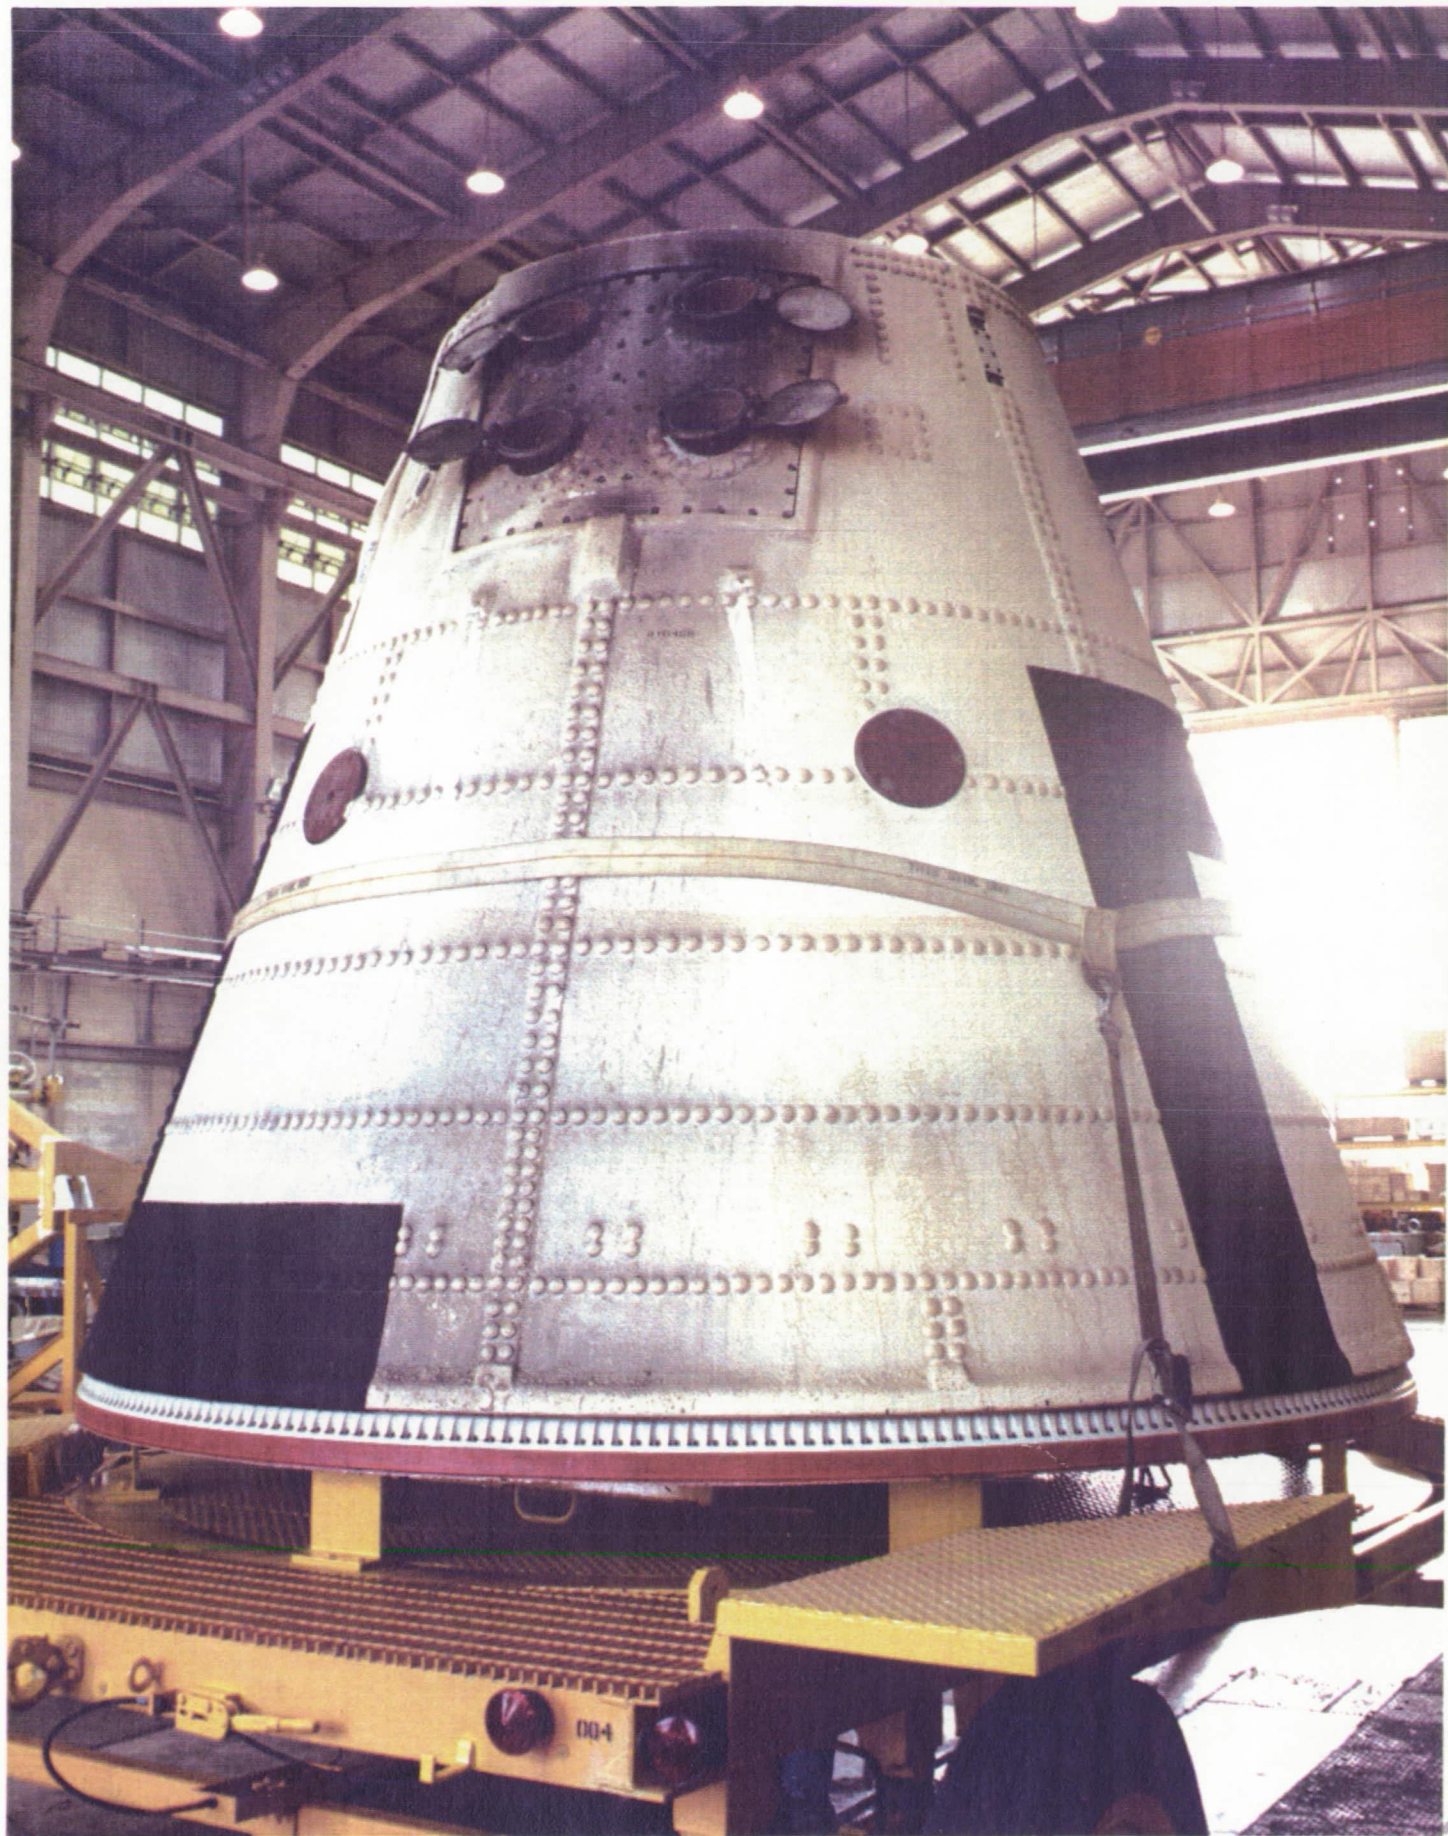
The RH frustum was missing no TPS but had 26 MSA-2 debonds over fasteners.

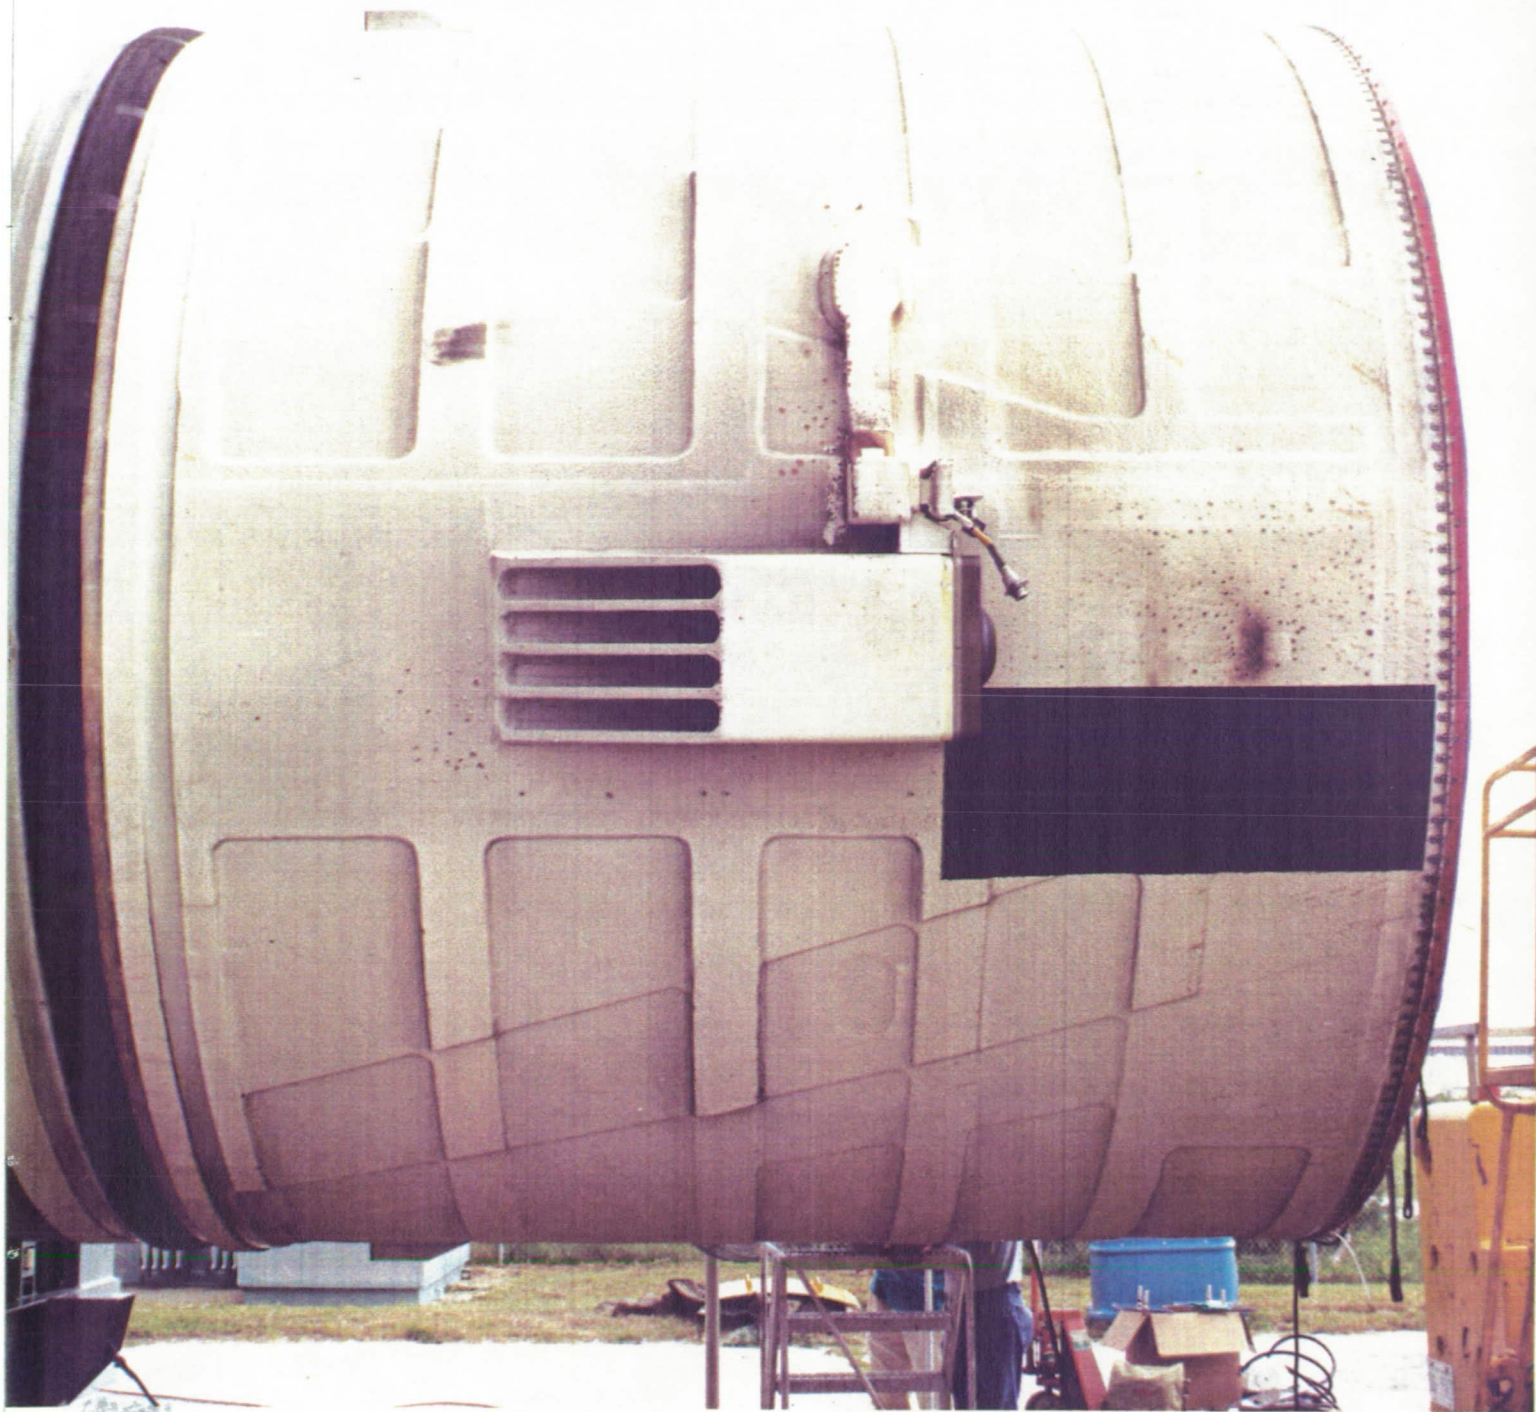
The RH forward skirt exhibited no debonds or missing TPS. Both RSS antenna phenolic plates were intact. Minor blistering of the Hypalon paint occurred forward of the ET/SRB attach point.
